THERMOGRAPHIC PROBLEM REPORT

Survey Date:
1/10/00

Facility: Vernon WPCA
Vernon, MA

Area/Equip.: Carbon Regeneration
Vapor Blower

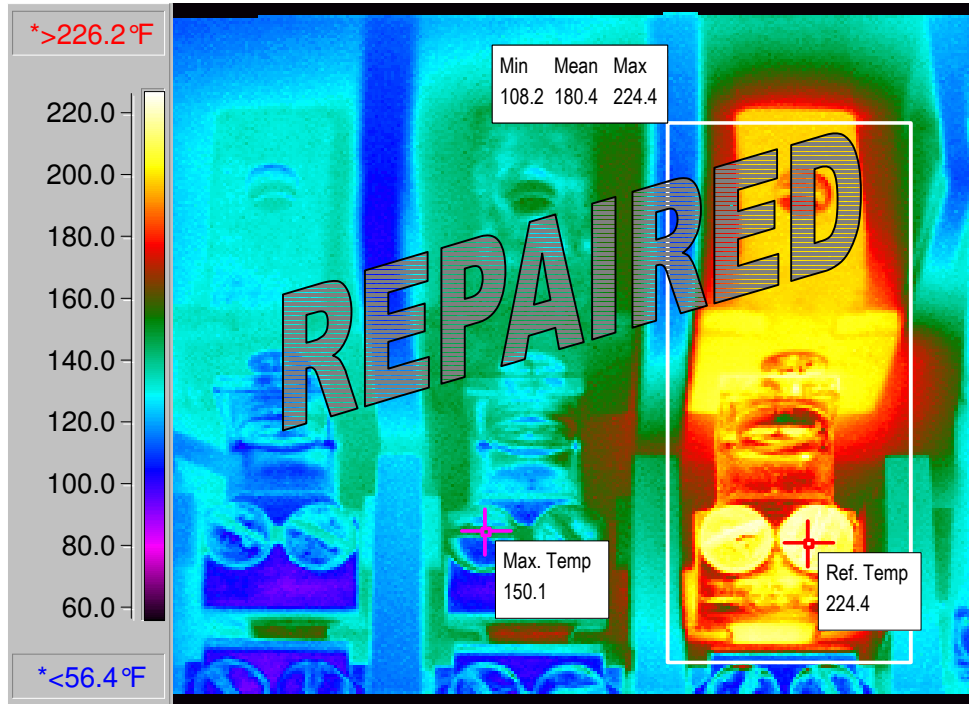
Findings: Dirty or loose connection at C phase buss. Heat generation is highest at upper bolt heads on overload.

224°F

74°F

125°F

Recommendations: Disassemble, inspect, clean and re-tighten buss.

Action Taken: Overload removed, cleaned and replaced. Minor corrosion and loose bolts found at overload.

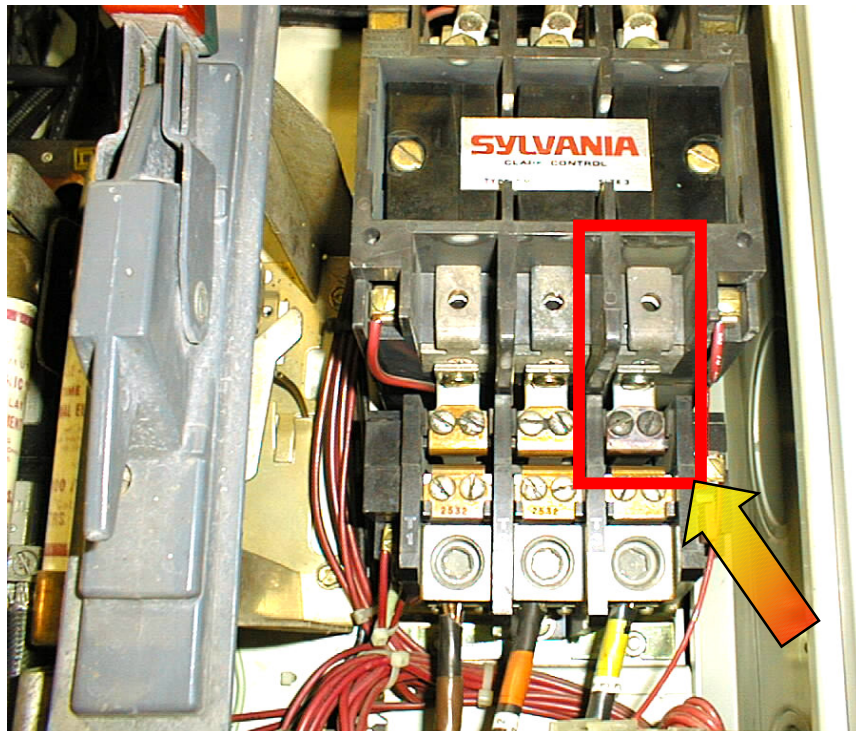
PROBLEM LOCATION

Main Contactor
C Phase
Line Side Overload
