THERMOGRAPHIC PROBLEM REPORT

Survey Date:
1/10/00

Facility: Vernon WPCA
Vernon, MA

Area/Equip.: Carbon Regeneration
Vapor Blower

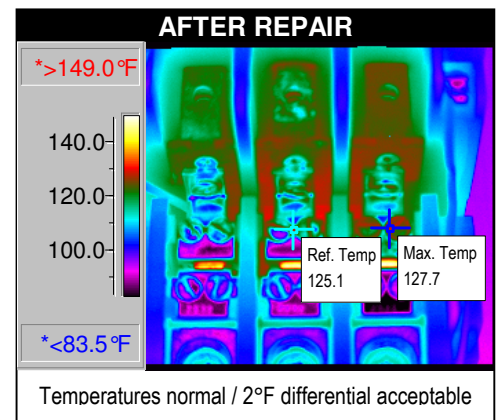
PROBLEM LOCATION

Findings: Dirty or loose connection at C phase buss. Heat generation is highest at upper bolt heads on overload.

224°F

74°F

125°F

Main Contactor
C Phase
Line Side Overload

Recommendations: Disassemble, inspect, clean and re-tighten buss.

Action Taken: Overload removed, cleaned and replaced. Minor corrosion and loose bolts found at overload.
